2019 Adirondack Aquatic Invasive Species Surveys

Early Detection Team Report

2019 Adirondack AIS Surveys

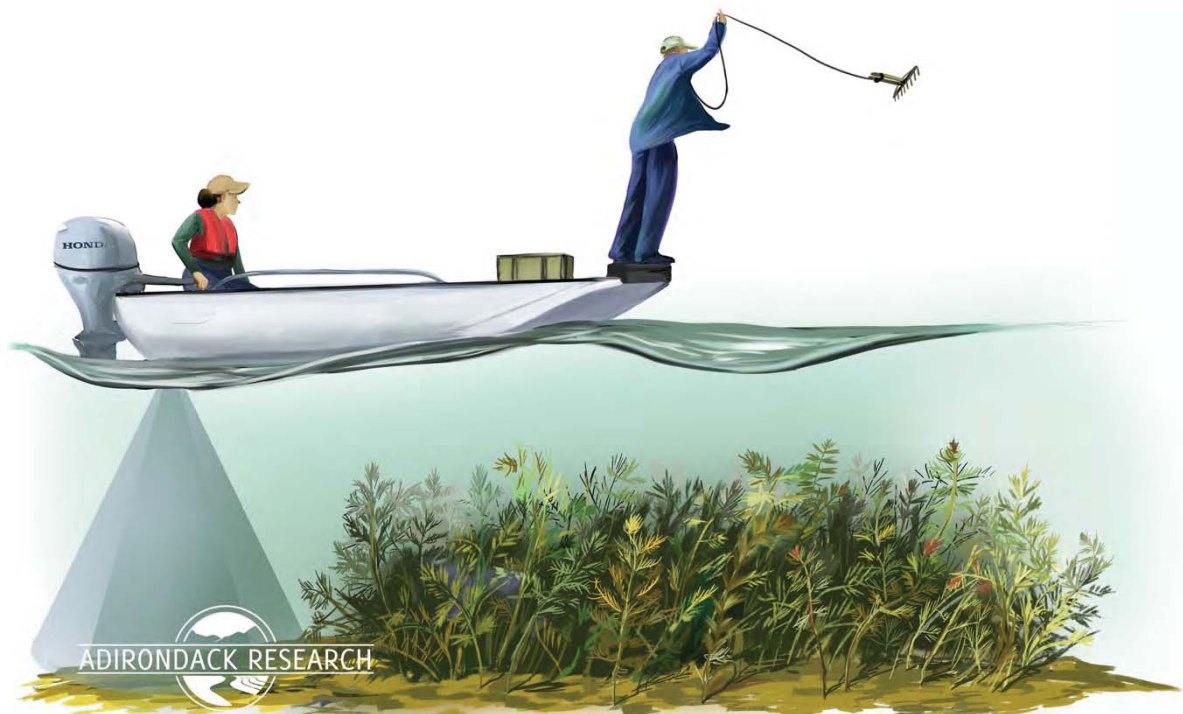
Figure 1: Illustration of the survey techniques utilizing a combination of sonar recording and manual rack toss.

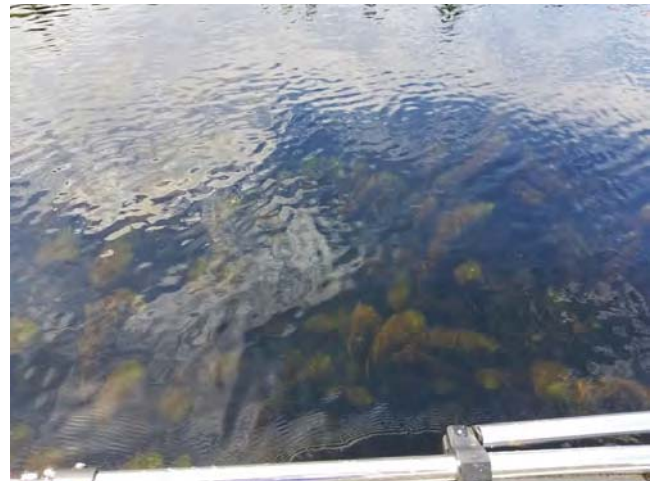
Photo 3: Variable leaf milfoil in Fifth Lake, Hamilton Co., NY.

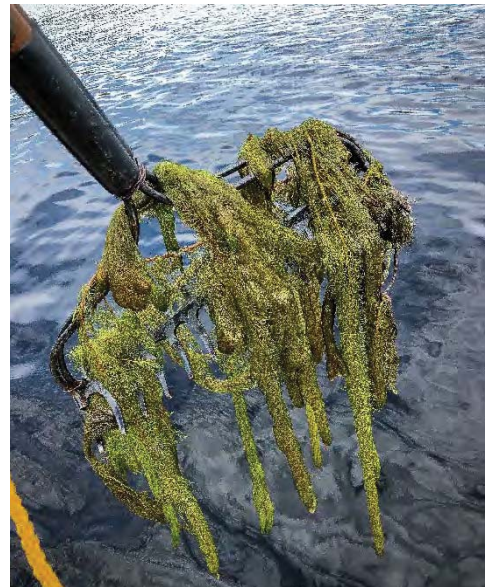
Photo 5: A rake covered with variable leaf milfoil from Piercefield Flow, St Lawrence Co., NY.

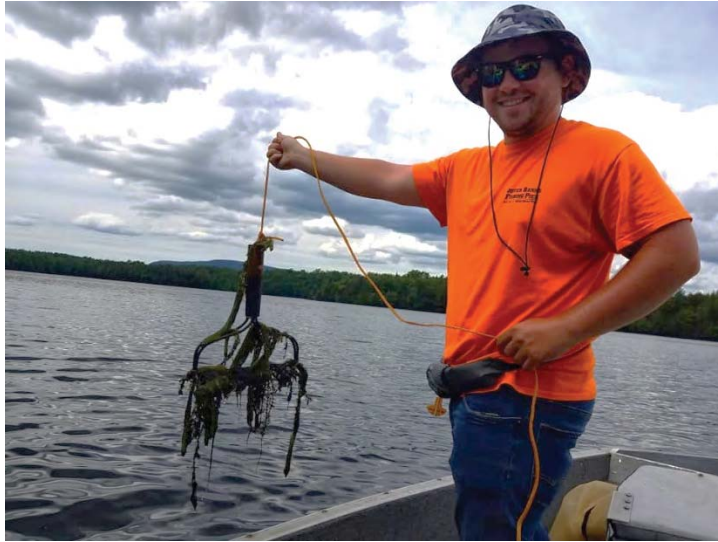
Photo 11: Research Technician Mason with a retrieved rake covered in variable leaf milfoil. Piercefild Flow, St Lawrence Co., NY.
